JOE GRAND AKA KINGPIN

THAT TIME I HACKED A HARDWARE
WALLET AND RECOVERED \$2 MILLION...

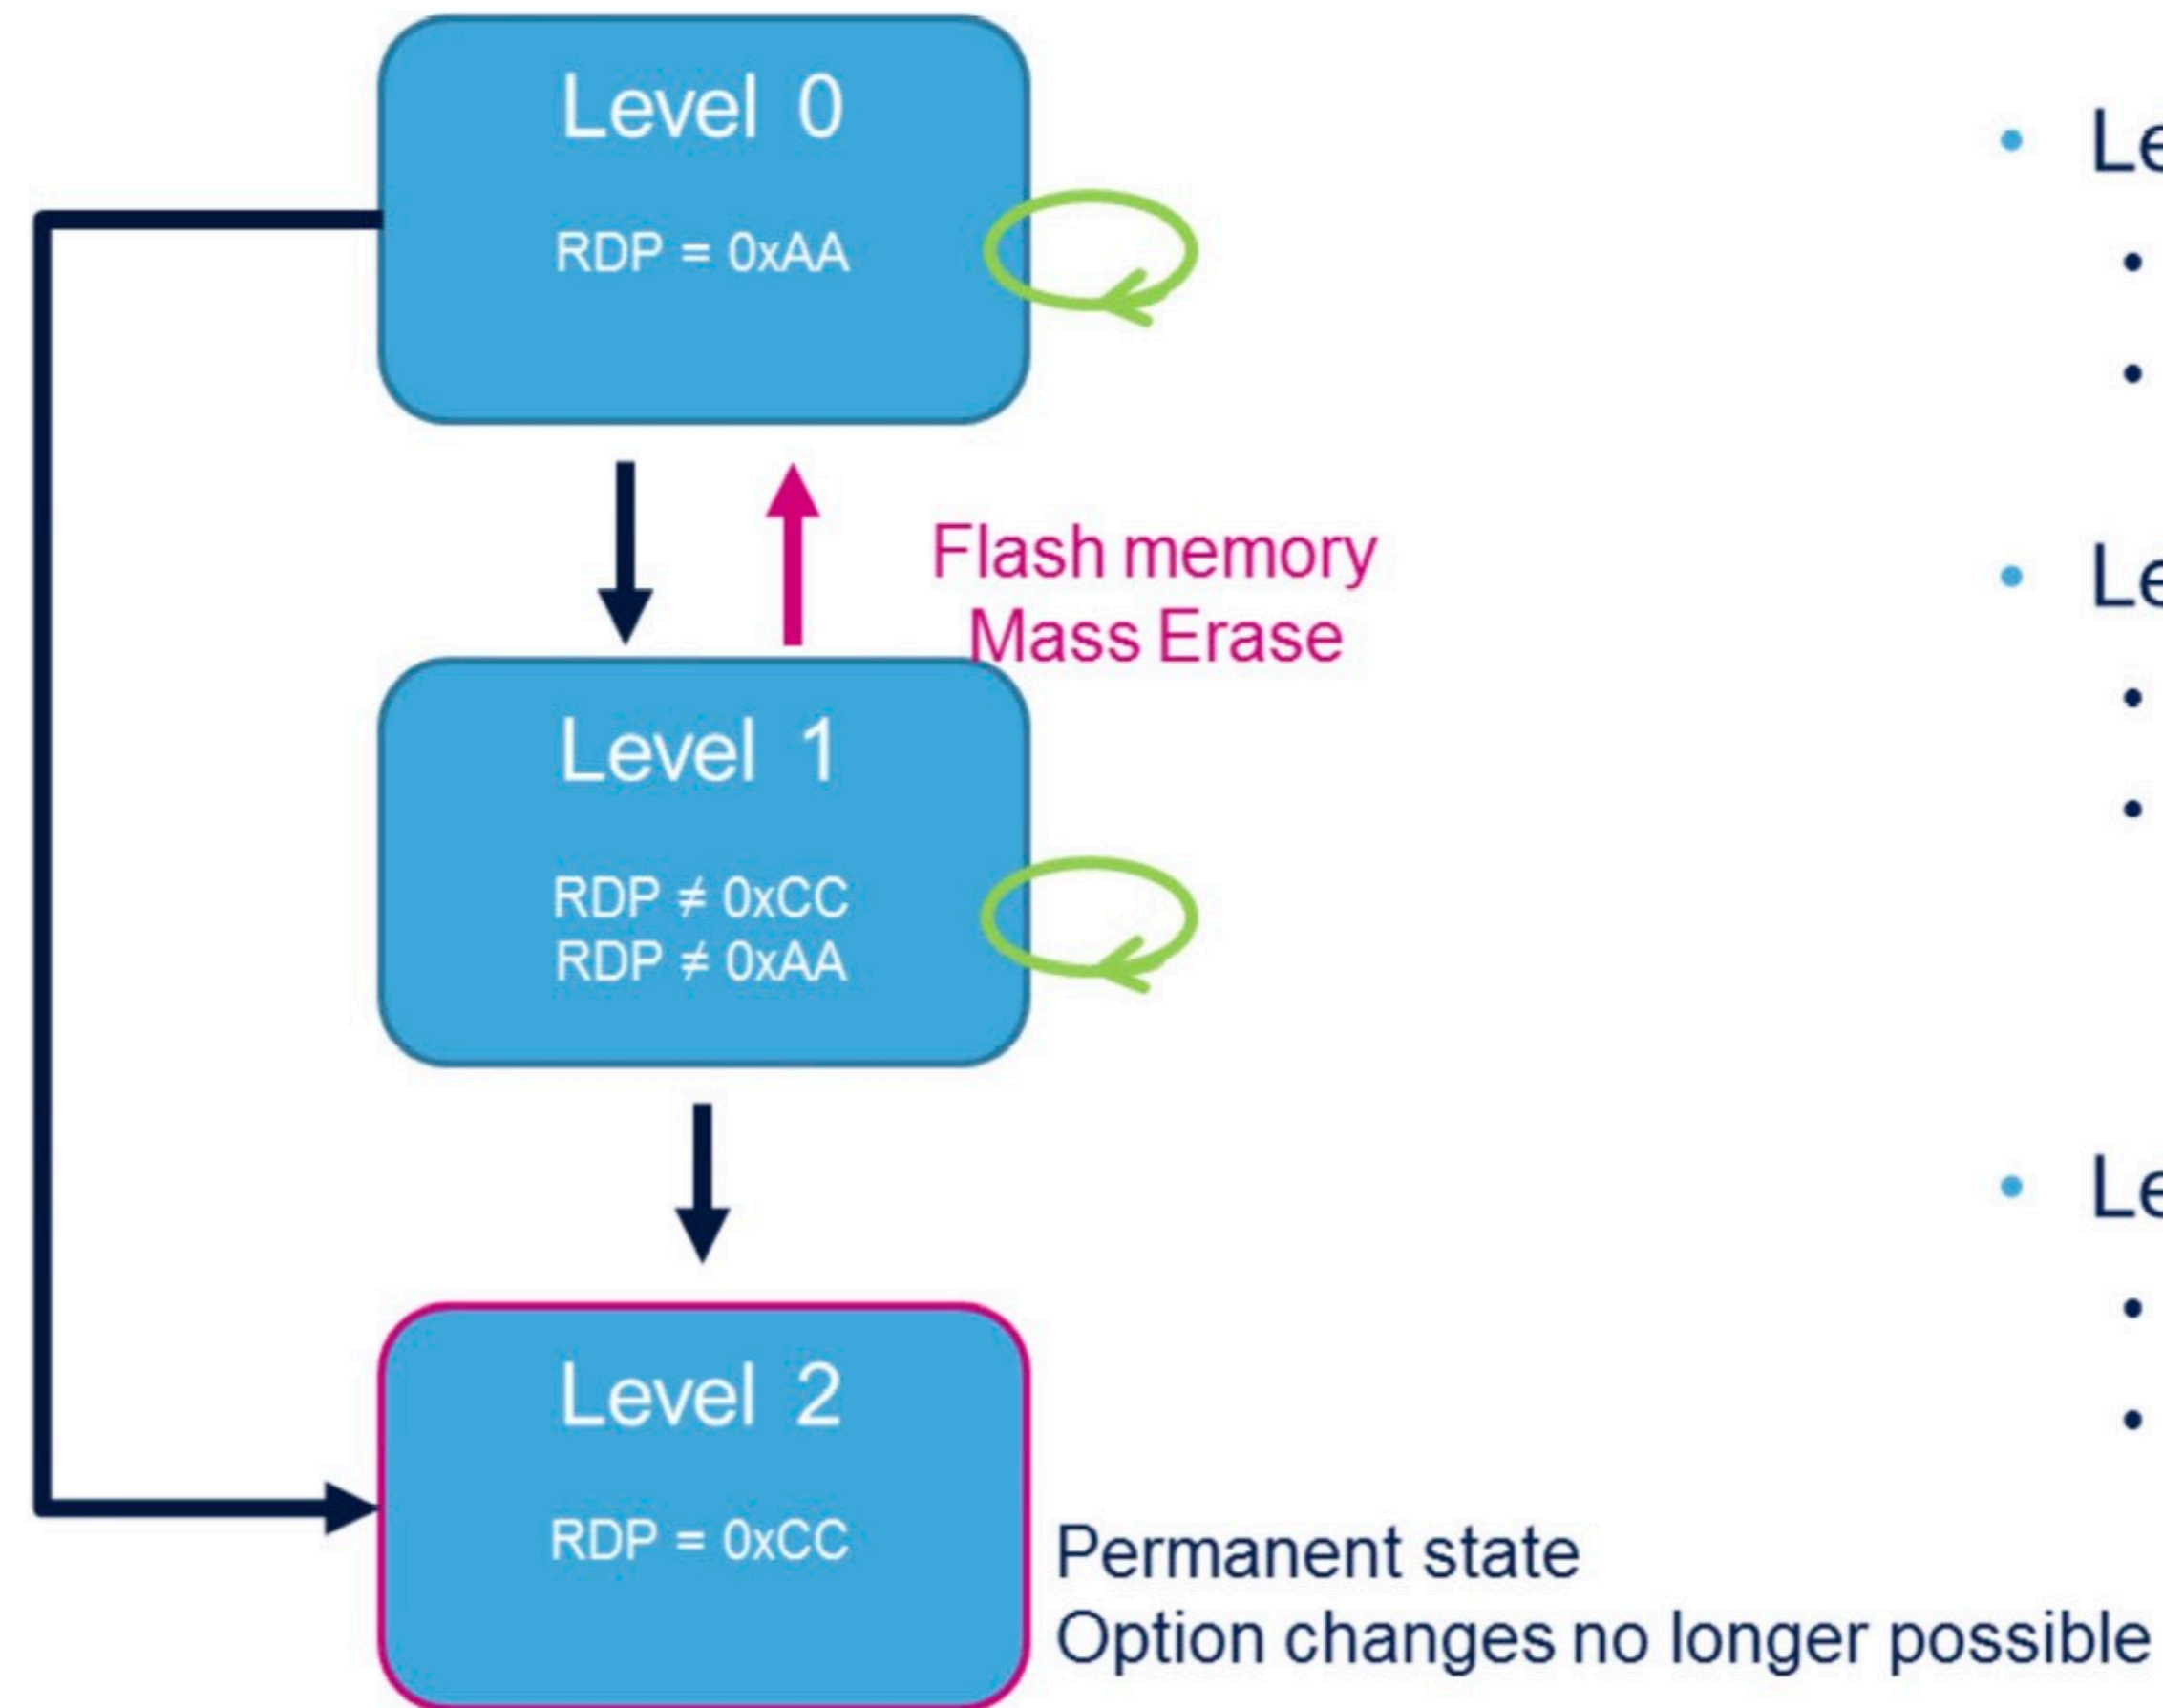
RDP transition scheme

- Level 0
 - Option byte mods are allowed
 - Can transition to Level 1 or Level 2
- Level 1
 - Option byte mods are allowed.
 - Can transition to Level 0 or Level 2
 - Level 0 → Mass erase of user Flash memory, backup regs and SRAM2
- Level 2
 - Option bytes are frozen
 - No transition possible
